INTERIM RCRA FACILITY ASSESSMENT REPORT

SAFETY-KLEEN CORPORATION Jackson, Mississippi

EPA I.D. No. MSD000776765

April 1990

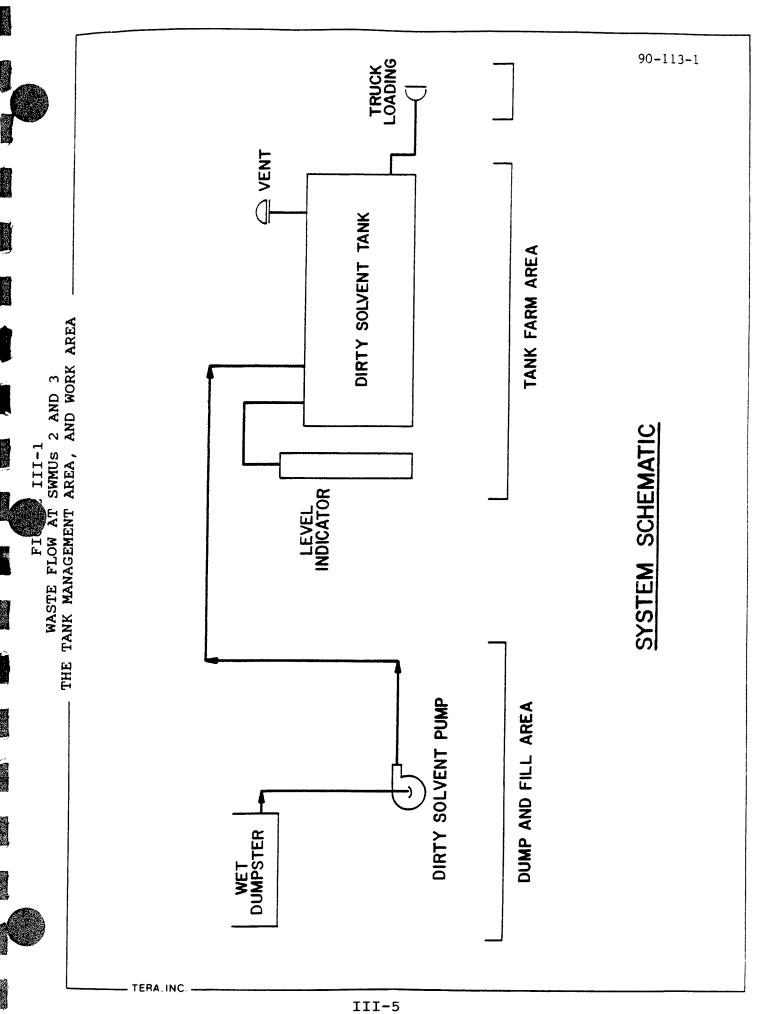
This RCRA-regulated unit consists of one 8,000 gallon tank, and one 4,000 gallon tank used to store waste mineral spirits. tanks reside within a concrete vault containment system, which is inspected yearly according to the facility representatives. The containment system is of poured, reinforced concrete construction. Its overall dimensions are (approximately) 35 feet by 28 feet by 36 inches in height, yielding a total containment capacity of approximately 22,000 gallons. At the time of the VSI it was observed to be a polyurethane coated concrete pad and wall system (a vault), apparently poured as one unit. There were no drainage points, or major cracks observed during the VSI, and there was approximately one to two inches of standing water in the unit apparently from the recent rains. Facility representatives reported that this water is visually checked for a sheen and if none is noted, then it is pumped out of the unit to the nearby soil. A recent (February) inspection performed by the facility indicated that the containment system was in "good condition". The current containment system only became operational in 1985 when the tanks came back under interim No information was available from the facility representatives with regard to a former containment system. tanks are of carbon steel construction, and are horizontally mounted on skids. Both are equipped with an emergency waste feed cut off and audible high level alarm systems, and vent directly to the atmosphere. The tanks are serviced by an above ground galvanized steel piping system, with associated pumps. pipes are of two or three inch diameter, and run from the Work Area (SWMU 3) to the tanks. They are serviced by an above ground galvanized steel piping system, with associated pumps. pipes are of two to three inch diameter, and run from the Work Area (SWMU 3) to the unit, and its tanks.

removed by a vacuum truck on an approximately yearly schedule according to the facility representatives. This sludge is returned to the recycle facility. The recent annual integrity assessment found both tanks to be in "good condition". No staining was observed in side the containment system, and neither tank appeared to be releasing at the time of the VSI.

There was no history of releases from this unit found in the file material, and none were observed during the VSI. However, given the facility's practice of dumping potentially contaminated water from the containment system to nearby soils, a potential for release to soils exists.

RECOMMENDATIONS: No Further Action ()
